## A seismically triggered landslide dam in Honshiyuan, Yunnan, China: from emergency management to hydropower potential

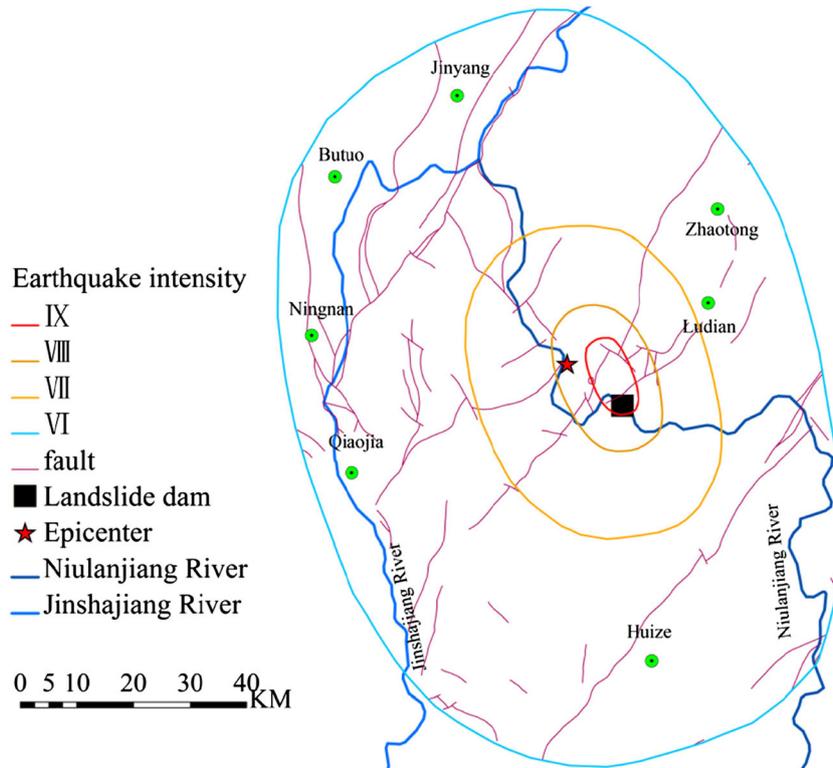
Fig. 2 Location of the epicenter and distribution of faults in Ludian earthquake region

The tectonics in the region along the Niulanjiang River is characterized by compound folds in the S-N and N-E directions, which are located in the southern section of the Yaoshan tectonic belt near the Xiaojiang fault zone. It is composed of a series of large-scale and high-development faults (Fig. 2).

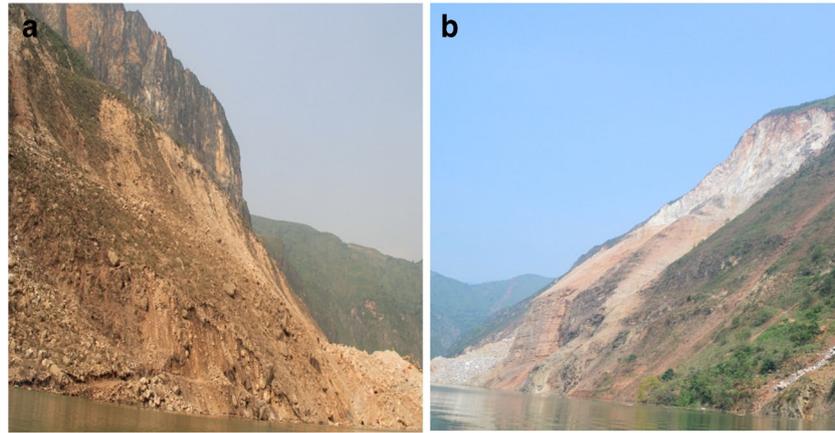
**Fig. 3** Two landslides induced by the Ludian earthquake form the landslide-dammed lake (a) Hongshiyuan landslide on left bank; (b) Chapingzi collapse on the right bank (view from upstream)

The debris deposit from the Hongshiyuan landslide and Chapingzi collapse was mainly composed of limestone (Fig. 3). However, there was a clear border in the accumulation body due to differing influence of weathering degree on the two banks (Fig. 8a). The surface of the Hongshiyuan landslide was covered by a dry layer of fine sediment with a maximum height of 109 m on the left bank (Fig. 4). The grain composition distribution of the fine sediment (shown in Fig. 5) indicated that the particles with a diameter less than 1 mm accounted for more than 85 % of the sample. This fine sediment is generated through a long separation process that might have originated in the sediment of the original Hongshiyuan reservoir.

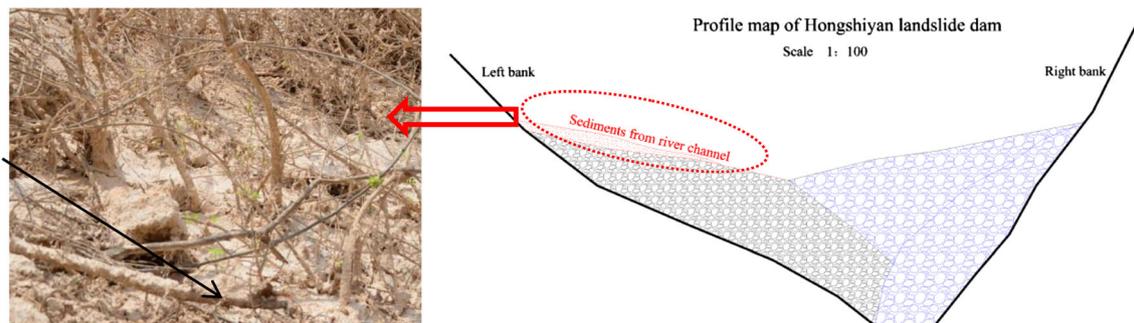
**Fig. 4** Conjectural profile map of the Hongshiyuan landslide dam based on field observations

channel. Impacted by the lifted sediment, some plants on the accumulation body of Hongshiyuan landslide overturned in the reverse slope direction (Fig. 4).

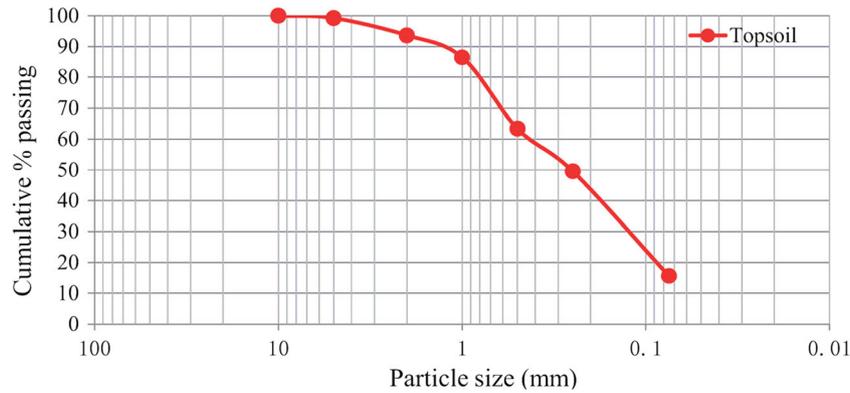
**Fig. 5** Cumulative grain size distribution of the topsoil

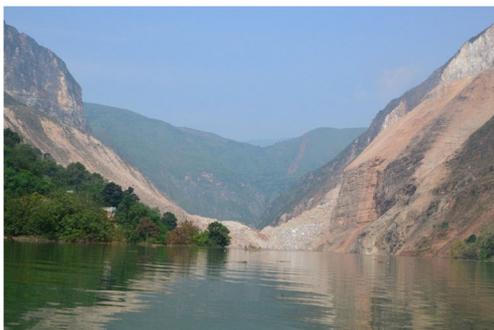
**Fig. 6** Panoramic view of the Hongshiyuan landslide dam. This photo was taken upstream of the landslide dam

The debris deposit from the Hongshiyuan landslide and Chapingzi collapse blocked the river channel with a V shape and formed the Hongshiyuan landslide dam (Fig. 6).

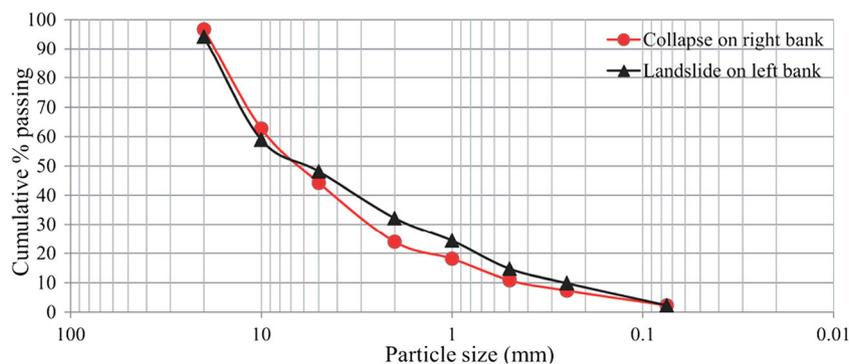
**Fig. 7** Cumulative grain size distributions of the samples obtained from left and right banks

Two samples of the debris deposit were collected from typical locations of the landslide and collapse, which were screening passed through sieves in the laboratory for analysis. The grain composition distribution of the samples from the left and right bank is shown in Fig. 7. Particles with a diameter of less than 1 mm accounted for 24.3 and 18.1 % of samples, respectively. This indicates abundant fine particles in the accumulation body of the landslide and collapse.

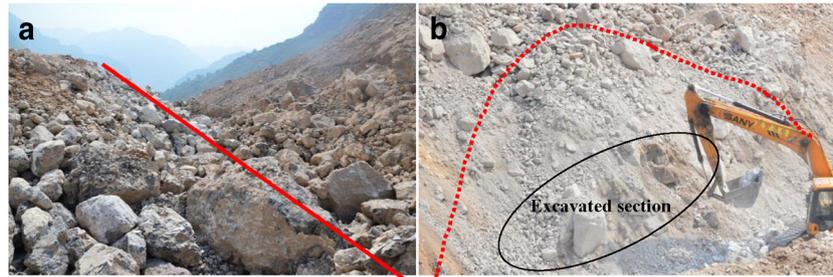
**Fig. 8** Pictures of the coarse particles in the debris deposit and the excavated section of the collapse on the right bank. **a** Photograph of the upstream direction. **b** The area within *black oval* is a typical matrix-support structure

An excavated section of the Chapingzi collapse on the right bank is shown in Fig. 8b. As is shown in this picture, the debris deposit and grain components in this section are best characterized by the matrix-supported type. The results of laboratory tests and field observation indicate that the structure of the Hongshiyuan landslide dam was formed by both coarse and fine particles.

Due to field conditions, particles with a diameter larger than 60 mm were not sampled. However, as shown in field pictures (Fig. 8a), coarse particles accounted for a large proportion of the debris deposit. The authors visually estimated that the boulder

Since the debris deposit of the Hongshiyuan landslide dam from the Chapingzi collapse is mainly composed of big rocks (Fig. 8a). If

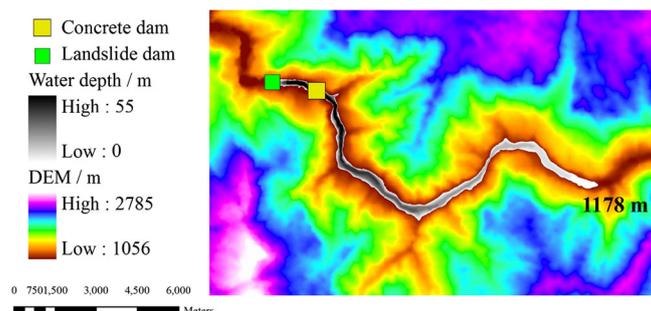
**Fig. 9** Measured depth data of Hongshiyuan landslide-dammed lake

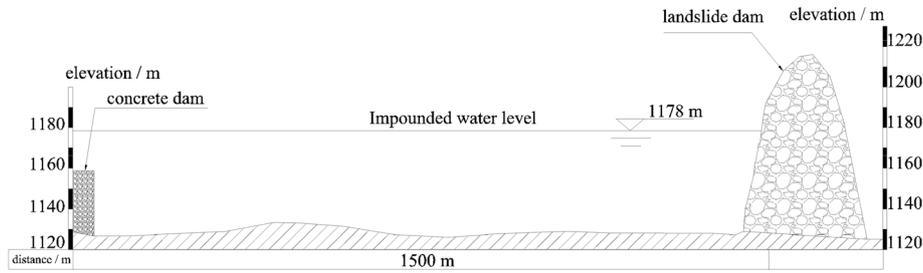
Plotting scale: horizontal 1:500, vertical 1:100

**Fig. 10** Profiles of Hongshiyuan landslide and artificial concrete dam that show the location relationship of the two dams

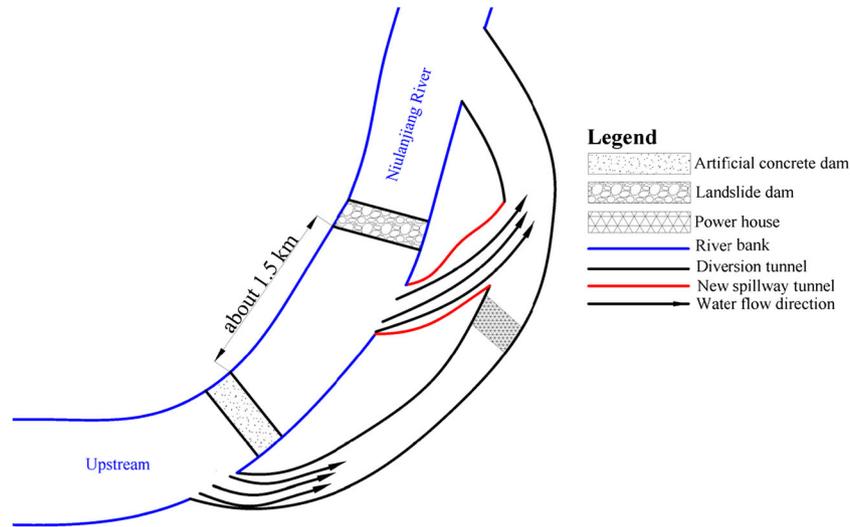
**Fig. 11** Schematic diagram of the suggested spillway tunnel. This picture also shows the location relationship of the artificial concrete dam, landslide dam, diversion tunnel, and the new spillway tunnel

The Hongshiyuan landslide dam can be transformed into an impounding dam similar to an embankment dam. The suggested hydro-junction that revolves around the Hongshiyuan landslide dam can only be implemented by using the diversion mode for power generation. The emergency spillway tunnel connected to the diversion tunnel of the Hongshiyuan hydropower station can be used for flood regulation and sediment scour. A new spillway outlet for the power generation system should be built on the right bank. The design of the new power generation scheme should take full consideration of the sediment deposition issue downstream of the powerhouse.

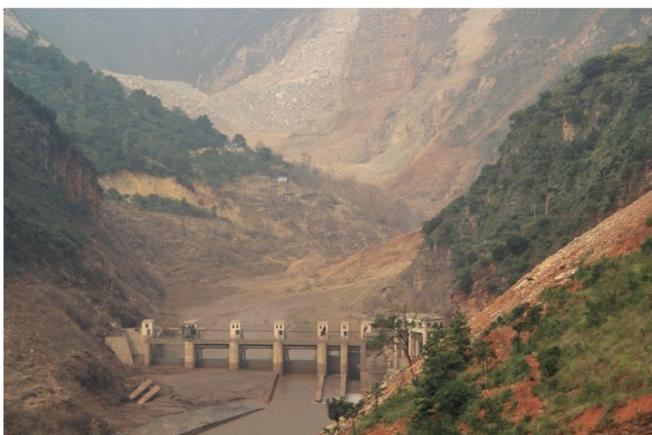
**Fig. 12** Water impounded in the dammed lake has been released by the new constructed channel. As shown in this picture taken on October 10th, the submerged artificial concrete dam has been exposed
