**Russian State Geological Prospecting University named after
Sergo Ordzhonikidze (RSGPU)**

Landslides hazard of Moscow cultural heritage sites

UNESCO, Paris 2019

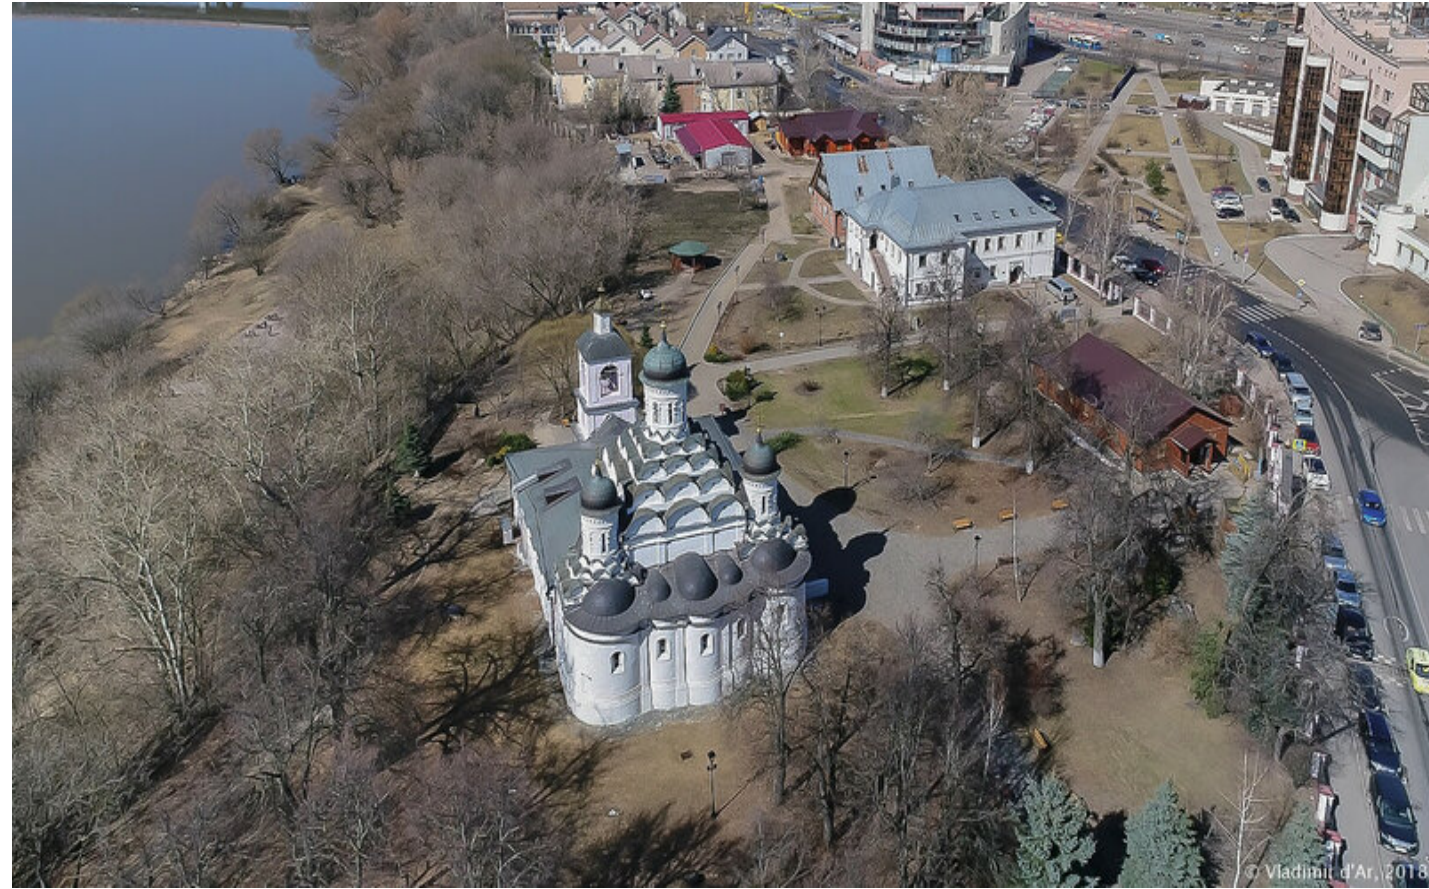
Holy Trinity Church in Khoroshevo

Regular observations took place since 1975 and lasts until now. Until 2006 some minor mudslides occurred. High accuracy observations lasts since 1977 until 1984. The highest mean displacements (86-91 mm) were near the river and decreased upslope up to 45-46 mm close to the top of the slope. Noticeable signs of deep deformations were not noticed.

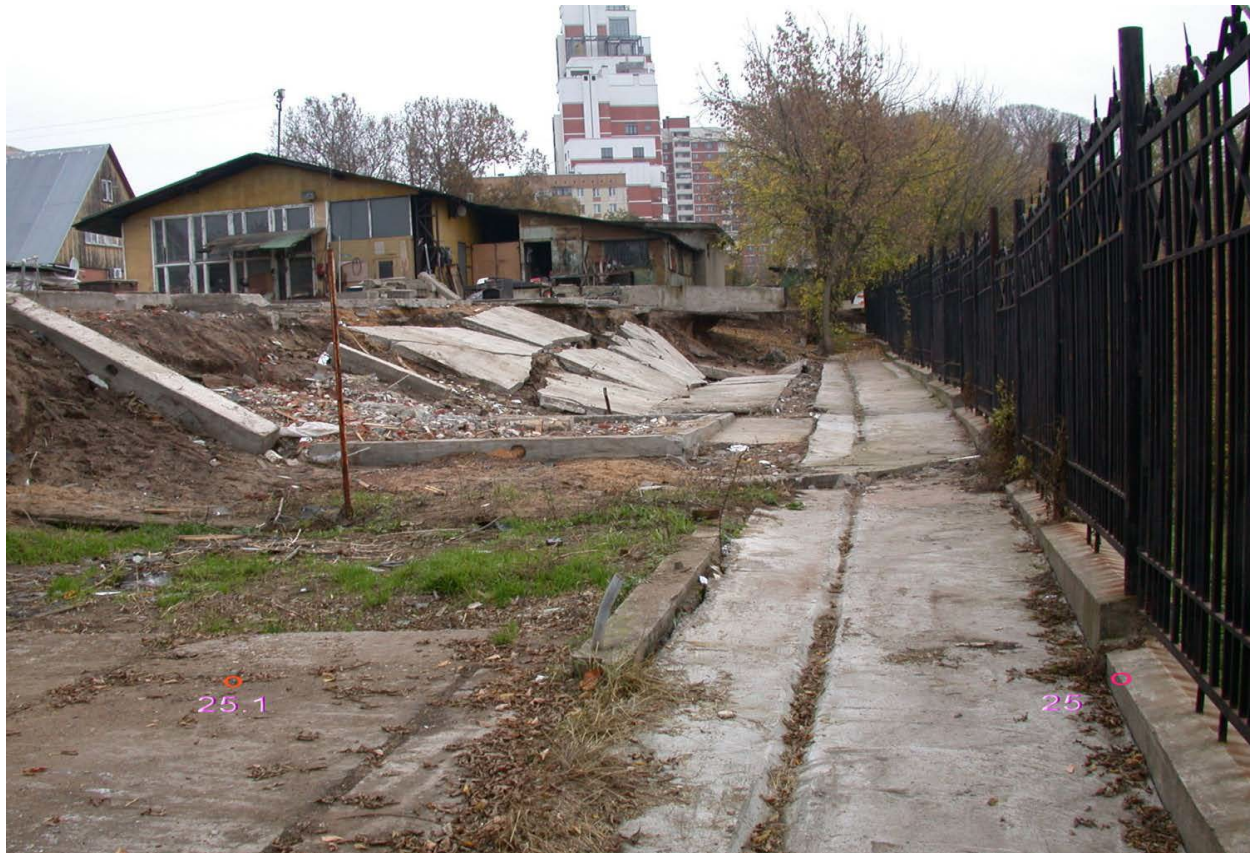
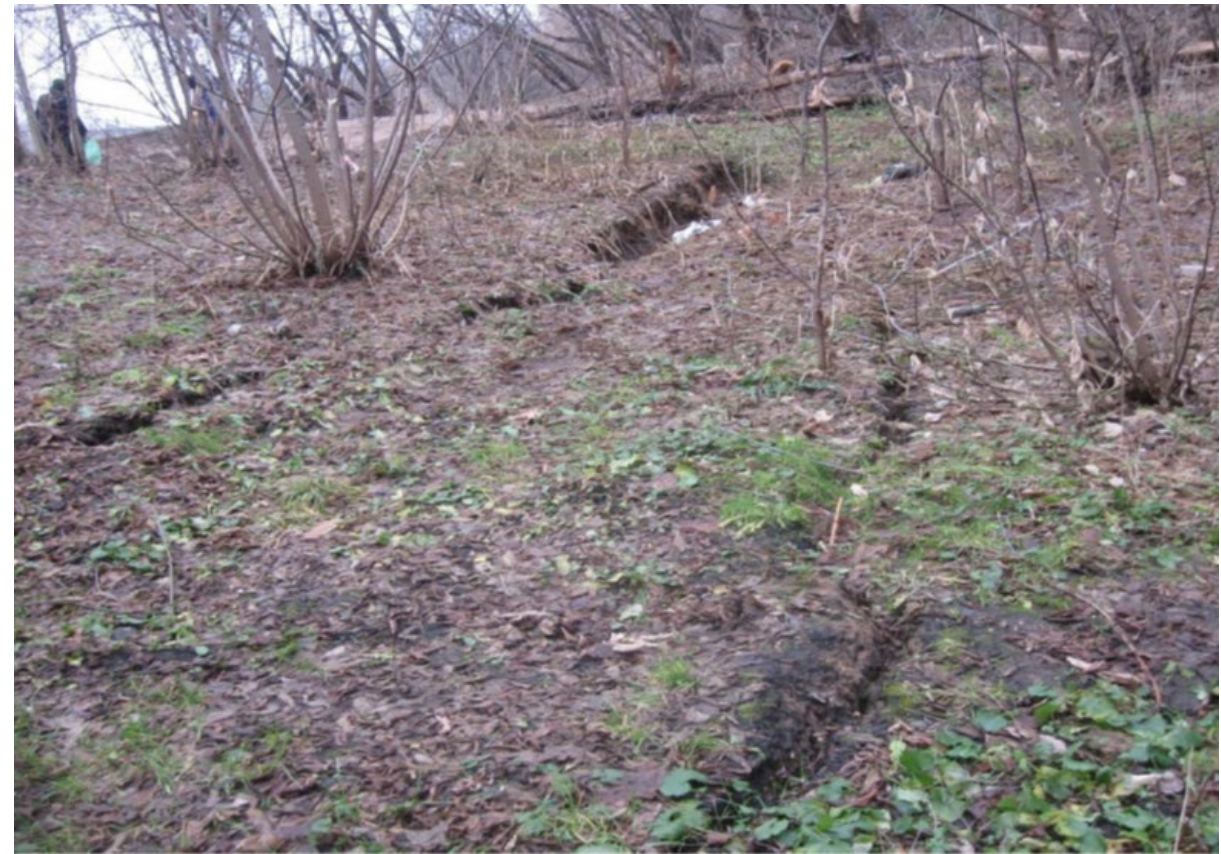
The main landslide displacement took place in 2006 it was about 300 m long and vertical displacement was 0,5-1,0 m, which then increased up to 3 m. Displacements occurred about 5 m from one of the cottages and 15 m from the church. It threatens to their safety.

The intensification of the landslide process coincided with the construction of the Zhivopisniy bridge, namely with the driving of piles for temporary supports in the southwestern part of the Khoroshevsky straightening. At the end of 2007, displacement rates decreased to 2 mm per month, but immediately after the opening of traffic on the bridge on January 7, 2008, they increased 4 times, reaching 2 mm per week. Thus, one of the reasons for the activation of the landslide process can be man-made impacts.
