## Landslides as hazard for Moscow cultural heritage

**Abstract** Blocked landslides are widespread in Moscow. The displacement of such landslides connects with Upper Jurassic clays. As a rule, these landslides have huge web depth. This depends on the possibility of huge damage. The last one obstructs stabilizing measures. Landslides have regressive (inside slope) development and durable (tens and hundreds of years) periods of slow deformations (1-30 centimeter per year). Such deformations give place to short periods of activation with displacements of some meters and more.

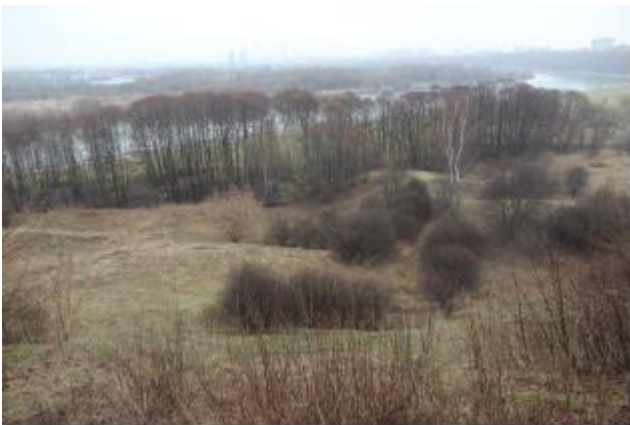
Figure 2. Hilly and depression relief at the base of slope in the Kolomenskoe near the Useknoveniya Glavy Ioanna Predtechi church. The relief is a result of the original sliding stages split

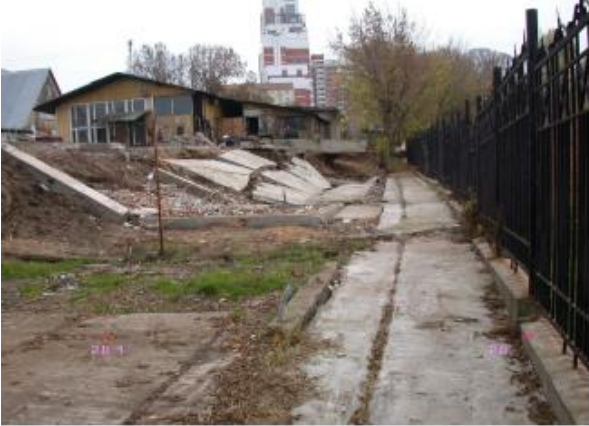
Figure 4. Wall disruption of sliding sub block and the widest part of slipping down the under rim part at the territory of Holy Trinity temple (12.10.06), sliding area Choroshevo-1

The main landslide displacement occurs in 2006. The length of wall disruption was 300 m, the height was 0,5-1,0 m, which then increased to 3 m. Wall disruption situated in 5 m from one of the cottages and 15 m from the church. It threatens to their safety (fig. 4-5).

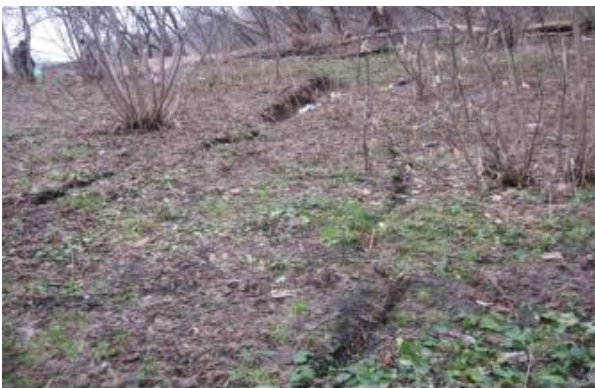
Figure 5 Sliding fracture of lower sliding blocks opposite the temple
